International Multi-Center Study for the Megagen Anyridge Implant System

Case Presentation

Dr Howard Gluckman
Cape Town
South Africa

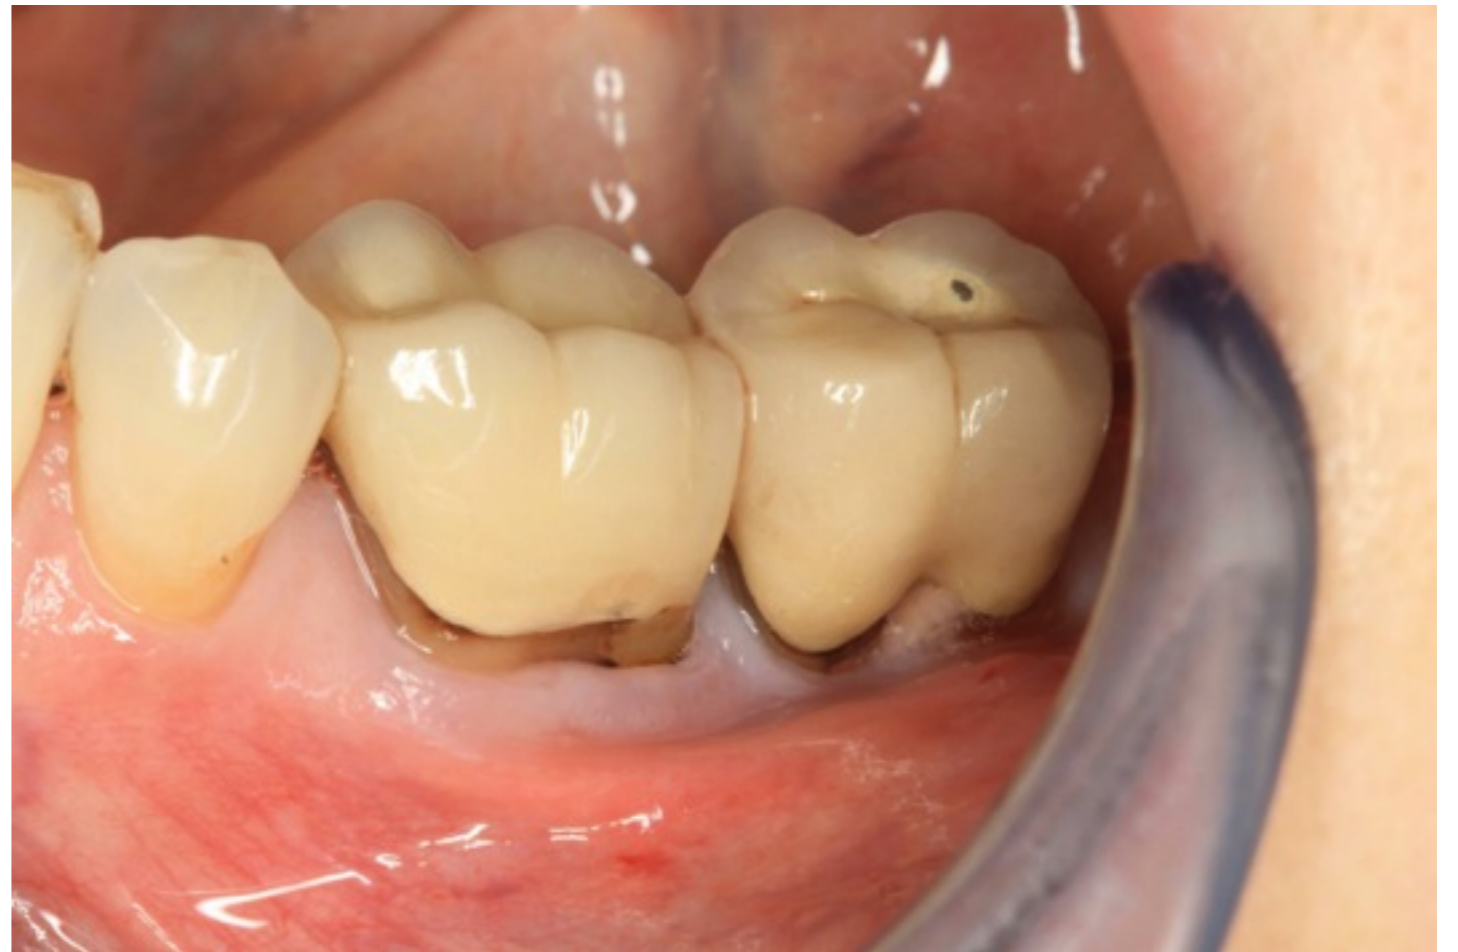
- MC: The patient presented with pain in both lower left molars.
- Clinical Examination showed subgingival root caries which extended into the furcation

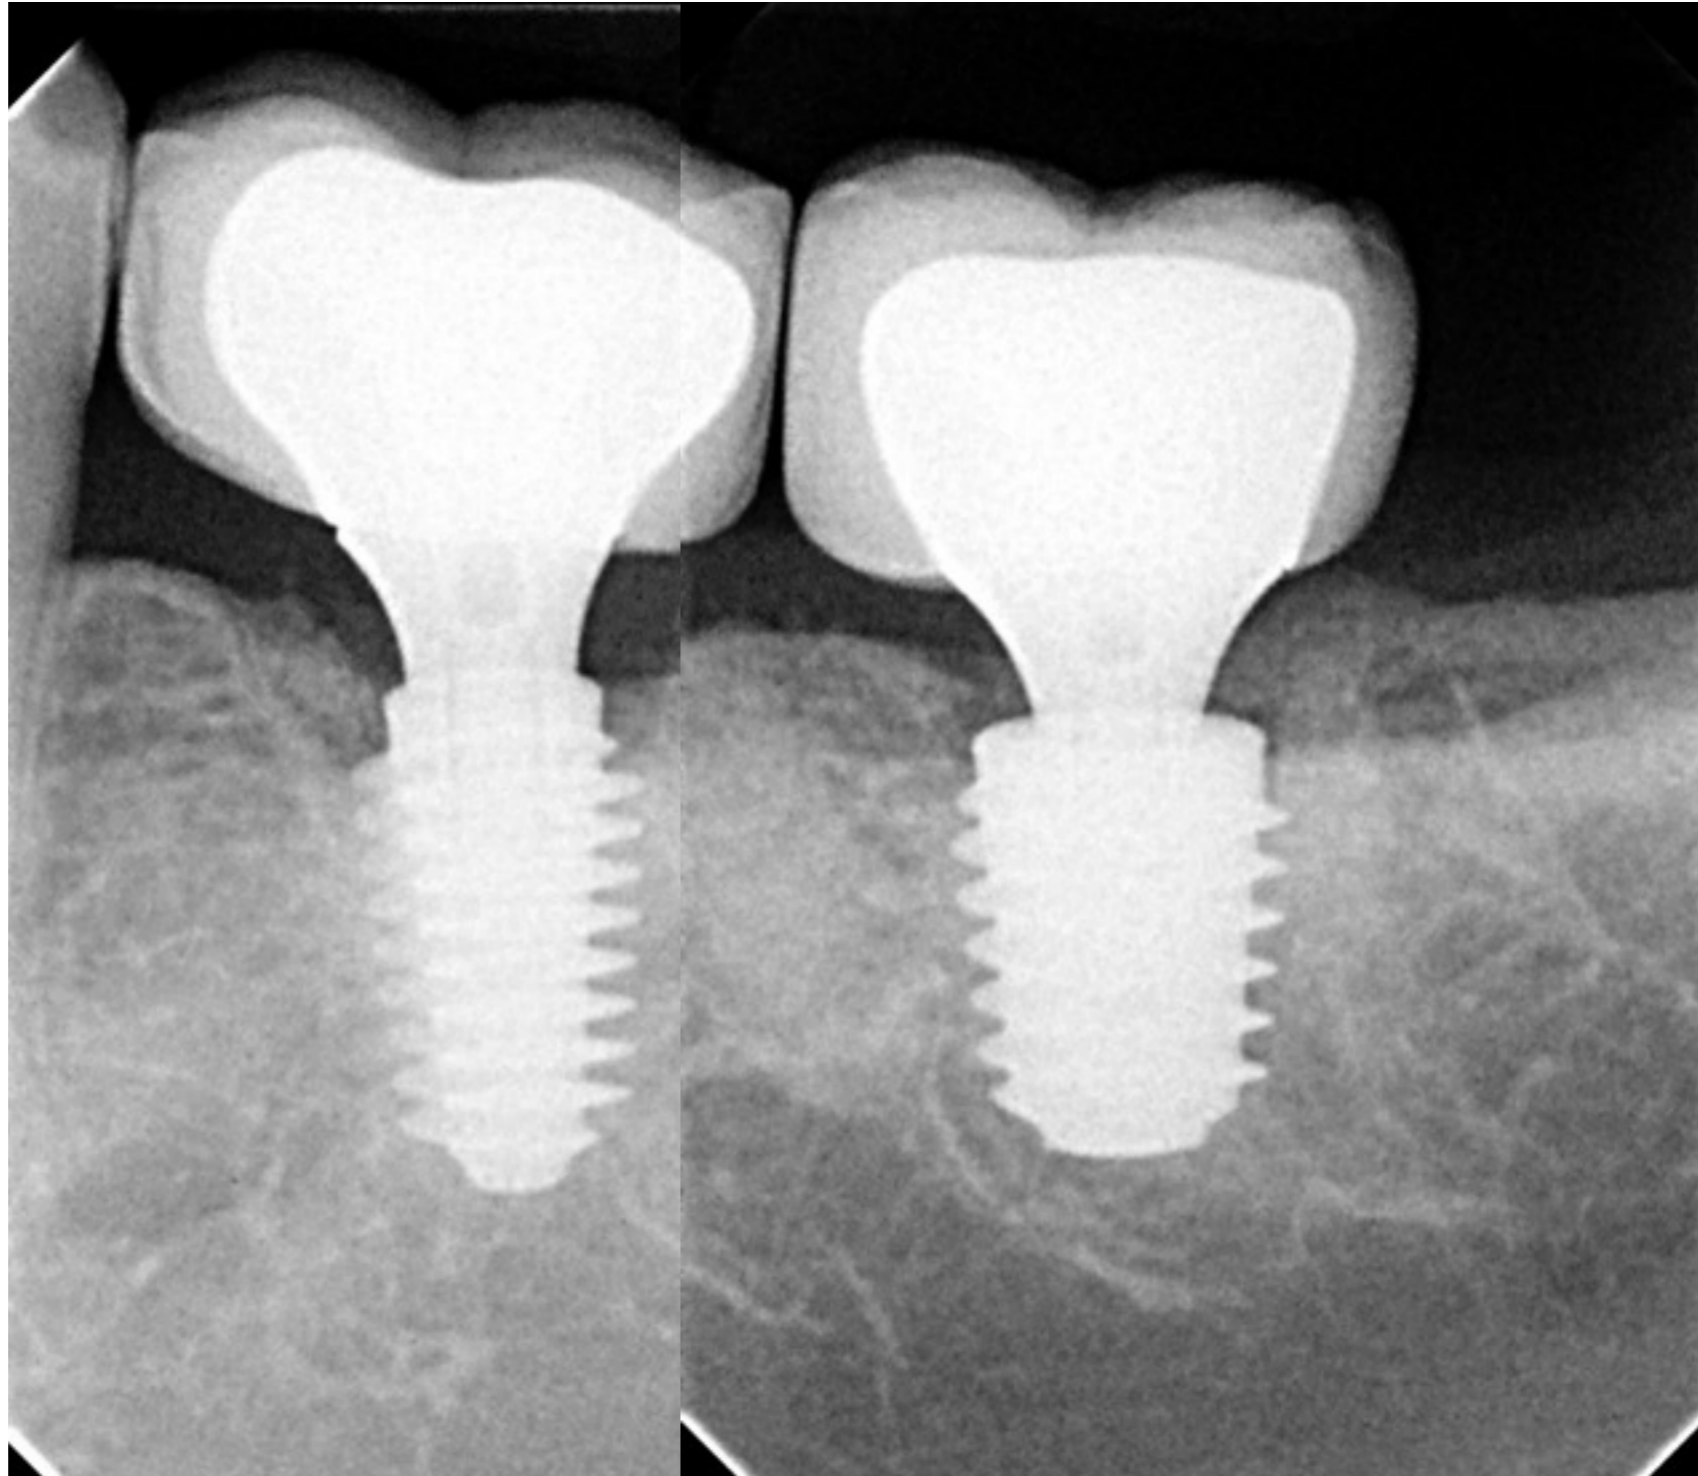
Excellent Bone maintenance 6 months post op
